Contract #: 04-0120F4Cty: SF/Ala Rte: 80 PM: 13.2/13.9File #: 69.28**WELDING INSPECTION REPORT****Resident Engineer:** Pursell, Gary**Address:** 333 Burma Road**City:** Oakland, CA 94607**Report No:** WIR-009225**Date Inspected:** 25-Sep-2009**Project Name:** SAS Superstructure**OSM Arrival Time:** 1900**Prime Contractor:** American Bridge/Fluor Enterprises, a JV**OSM Departure Time:** 700**Contractor:** Zhenhua Port Machinery Company, Ltd (ZPMC), Changxing Island **Location:** Shanghai, China**CWI Name:** See below**CWI Present:** Yes No**Inspected CWI report:** Yes No N/A**Rod Oven in Use:** Yes No N/A**Electrode to specification:** Yes No N/A**Weld Procedures Followed:** Yes No N/A**Qualified Welders:** Yes No N/A**Verified Joint Fit-up:** Yes No N/A**Approved Drawings:** Yes No N/A**Approved WPS:** Yes No N/A**Delayed / Cancelled:** Yes No N/A**Bridge No:** 34-0006**Component:** OBG Components**Summary of Items Observed:**

Bay 8

WELDING INSPECTION REPORT

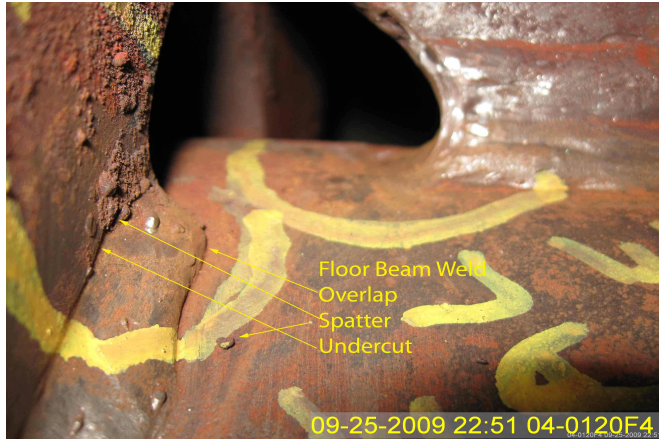
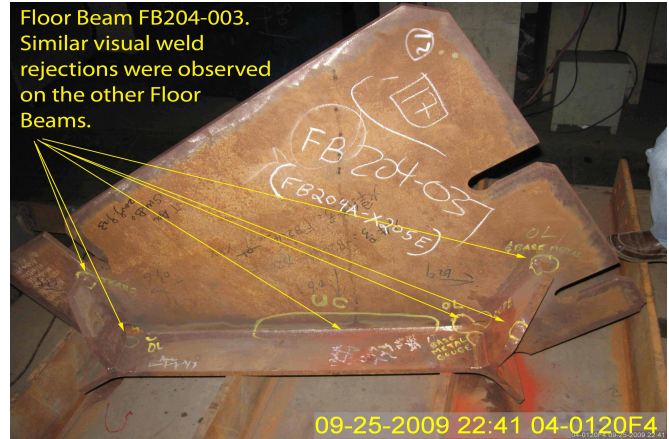
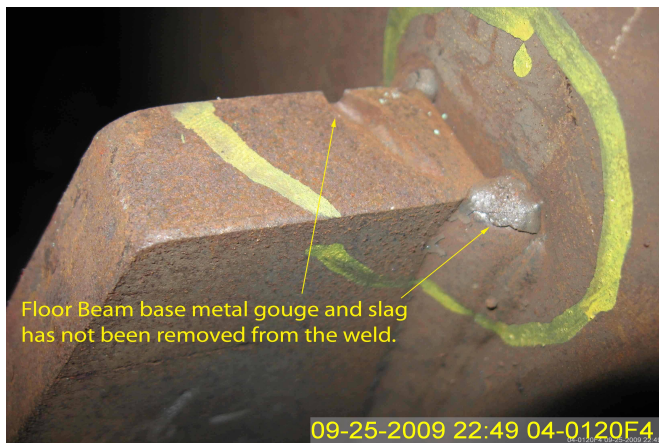
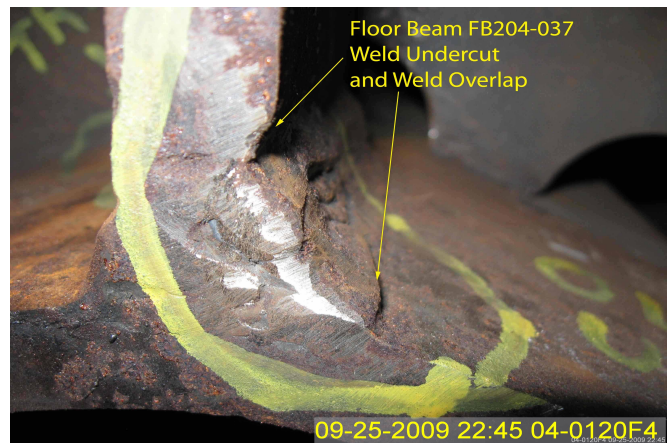
This QA Inspector, George Goulet, performed random visual inspection (VT) of the area previously tested and accepted by ZPMC Quality Control CWI Sun Bo (QC1). The members were identified as OBG floor beams FB204-037, FB204-038, FB204-039, FB204-040, FB205-037, FB205-038, FB205-039, FB205-040. This QA inspector began reviewing welds on one of four members marked as FB204-037 and also marked individually as FB204A-X205E. This QA inspector observed numerous areas of undercut, overlap, abrupt transition of weld to base metal, and base metal gouges by both grinding and torch.

Caltrans OSM Quality Assurance Inspector Larry Viars observed the same or similar conditions on members marked as FB204-038, FB204-039, FB204-040, FB205-037, FB205-038, FB205-039, FB205-040. This QA inspector generated an incident report concerning the above noted issues. MT was not performed by either of the above noted Caltrans representatives.
